Thermal Imaging Inspections

Infrared Termite Report

THERMAL IMAGING INSPECTION REPORT

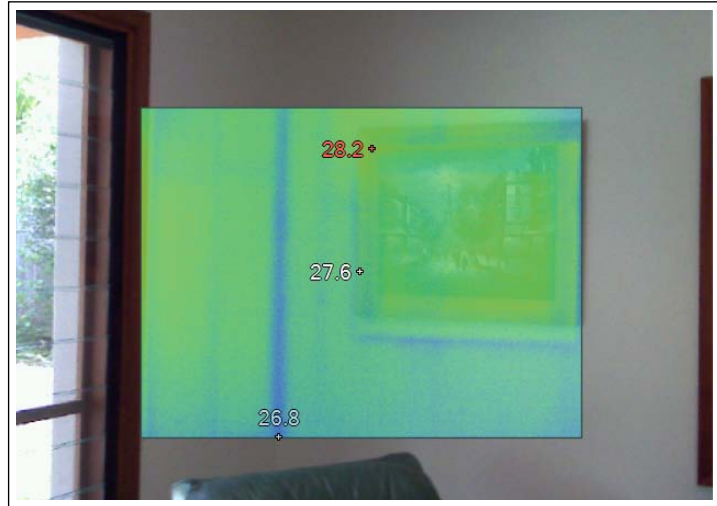
LOUNGE ROOM

Obstructions:	Furniture
Visible Indications:	Nil
Location of Image:	Wall
Thermal Anomaly:	No thermal anomalies noted
Explanation:	No evidence of termite activity. The presence of termites is suspected when the temperature range in any image is greater than 5 degrees. As recorded in the image above, the temperature range is 1.4 degrees.
Recommendations:	Remove obstructions and re-scan. Risk of concealed activity/damage is high due to the obstructions. Risk of imminent attack is high. Re-inspect in six months.

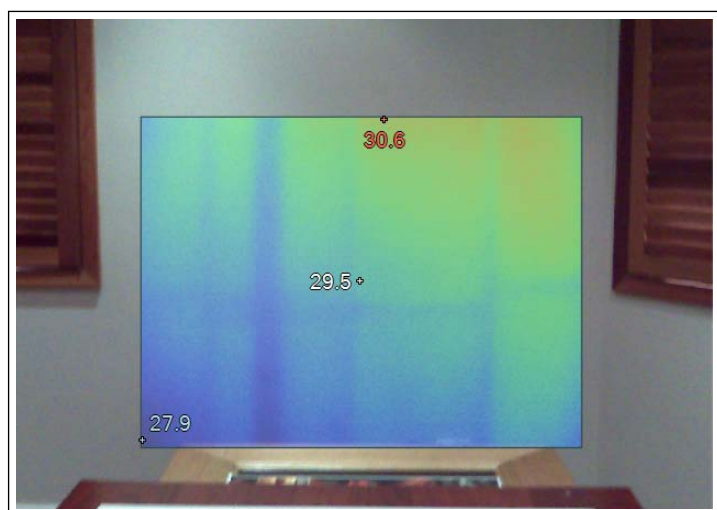
DINING ROOM

Obstructions:	Furniture
Visible Indications:	Nil
Location of Image:	Wall
Thermal Anomaly:	No thermal anomalies noted
Explanation:	No evidence of termite activity. The presence of termites is suspected when the temperature range in any image is greater than 5 degrees. As recorded in the image above, the temperature range is 2.7 degrees.
Recommendations:	Remove obstructions and re-scan. Risk of concealed activity/damage is high due to the obstructions. Risk of imminent attack is high. Re-inspect in six months.

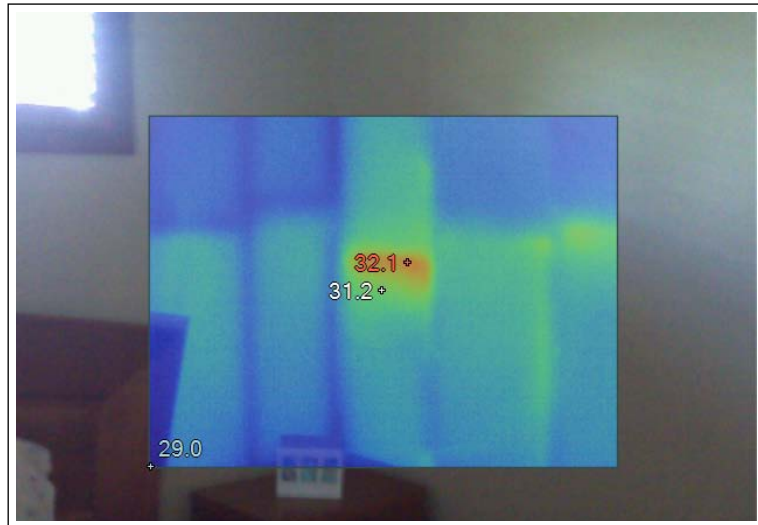
MASTER BEDROOM

Obstructions:	Furniture
Visible Indications:	Nil
Location of Image:	Wall
Thermal Anomaly:	No thermal anomalies noted
Explanation:	Termite activity suspected in The presence of termites is suspected when the temperature range in any image is greater than 5 degrees. As recorded in the image above, the temperature range is 3.1 degrees.
Recommendations:	Remove obstructions and re-scan. Risk of concealed activity/damage is high due to the obstructions. Risk of imminent attack is high. Re-inspect in six months.

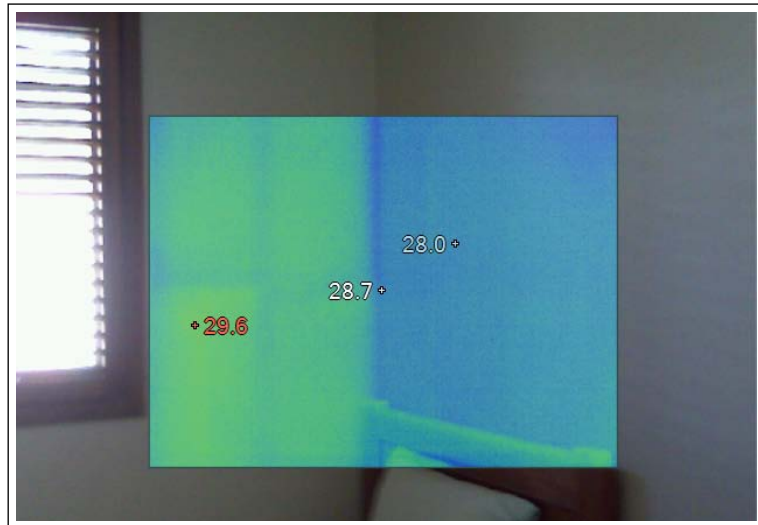
SECOND BEDROOM

Obstructions:	Furniture
Visible Indications:	Nil
Location of Image:	Wall
Thermal Anomaly:	No thermal anomalies noted
Explanation:	Termite activity suspected in The presence of termites is suspected when the temperature range in any image is greater than 5 degrees. As recorded in the image above, the temperature range is 1.6 degrees.
Recommendations:	Remove obstructions and re-scan. Risk of concealed activity/damage is high due to the obstructions. Risk of imminent attack is high. Re-inspect in six months.

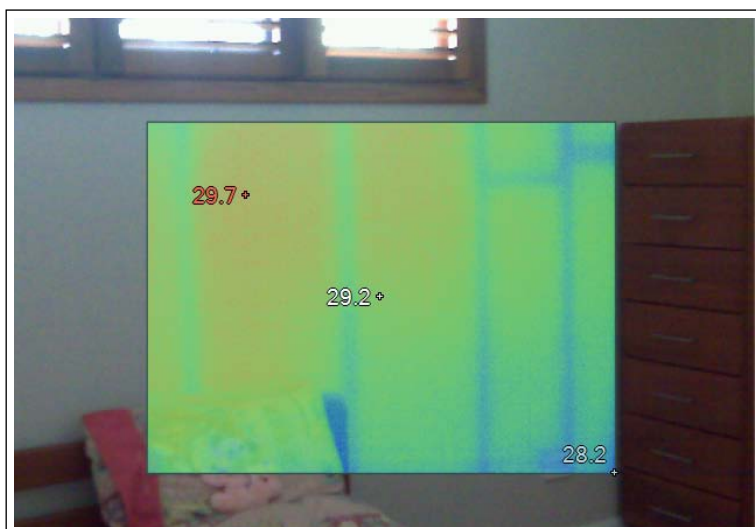
THIRD BEDROOM

Obstructions:	Furniture
Visible Indications:	Nil
Location of Image:	Wall
Thermal Anomaly:	No thermal anomalies noted
Explanation:	Termite activity suspected in The presence of termites is suspected when the temperature range in any image is greater than 5 degrees. As recorded in the image above, the temperature range is 1.5 degrees.
Recommendations:	Remove obstructions and re-scan. Risk of concealed activity/damage is high due to the obstructions. Risk of imminent attack is high. Re-inspect in six months.

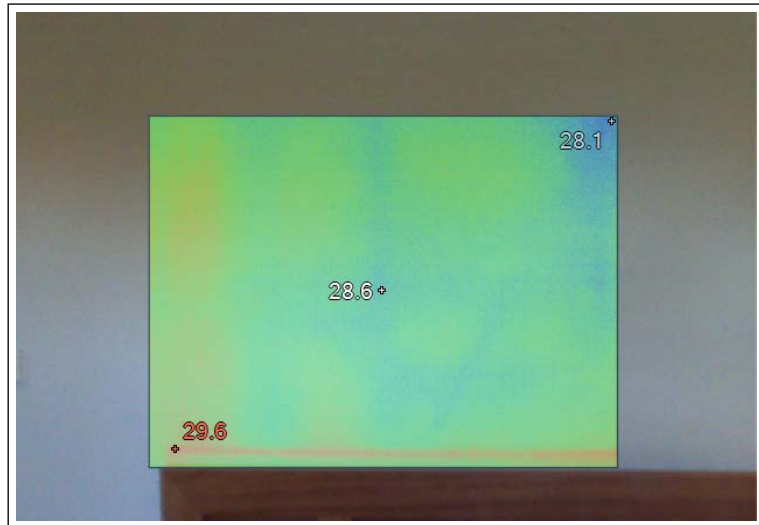
FOURTH BEDROOM

Obstructions:	Furniture
Visible Indications:	Nil
Location of Image:	Wall
Thermal Anomaly:	No thermal anomalies noted
Explanation:	Termite activity suspected in The presence of termites is suspected when the temperature range in any image is greater than 5 degrees. As recorded in the image above, the temperature range is 1.5 degrees.
Recommendations:	Remove obstructions and re-scan. Risk of concealed activity/damage is high due to the obstructions. Risk of imminent attack is high. Re-inspect in six months.

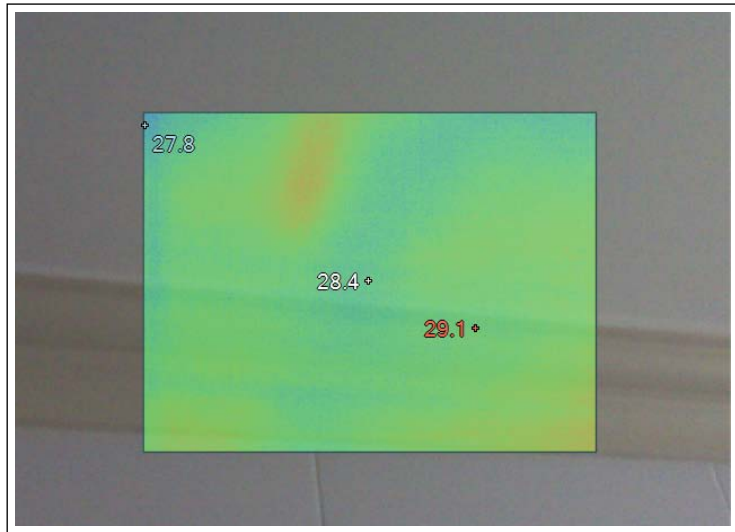
ENSUITE BATHROOM

Obstructions:	Amenities and tiled walls
Visible Indications:	Nil
Location of Image:	Wall
Thermal Anomaly:	No thermal anomalies noted
Explanation:	No evidence of termite activity. The presence of termites is suspected when the temperature range in any image is greater than 5 degrees. As recorded in the image above, the temperature range is 1.3 degrees.
Recommendations:	Remove obstructions and re-scan. Risk of concealed activity/damage is high due to the obstructions. Risk of imminent attack is high. Re-inspect in six months.

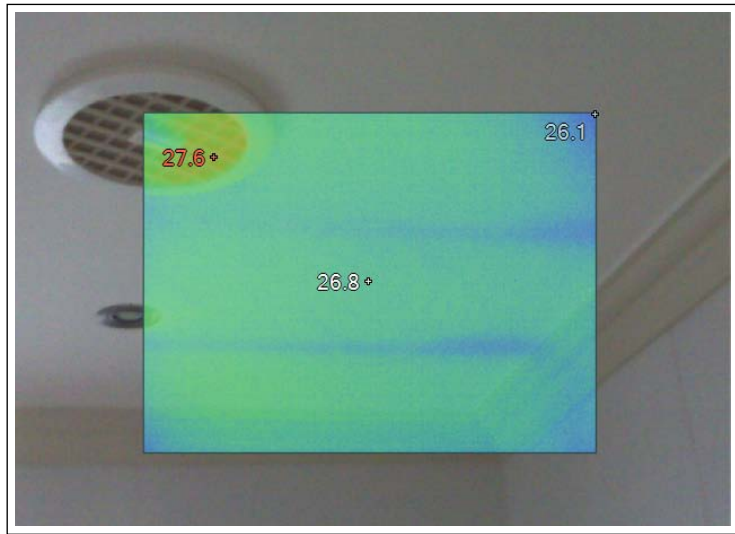
GROUND FLOOR BATHROOM

Obstructions:	Amenities and tiled walls
Visible Indications:	Nil
Location of Image:	Wall
Thermal Anomaly:	No thermal anomalies noted
Explanation:	No evidence of termite activity. The presence of termites is suspected when the temperature range in any image is greater than 5 degrees. As recorded in the image above, the temperature range is 1.5 degrees.
Recommendations:	Remove obstructions and re-scan. Risk of concealed activity/damage is high due to the obstructions. Risk of imminent attack is high. Re-inspect in six months.

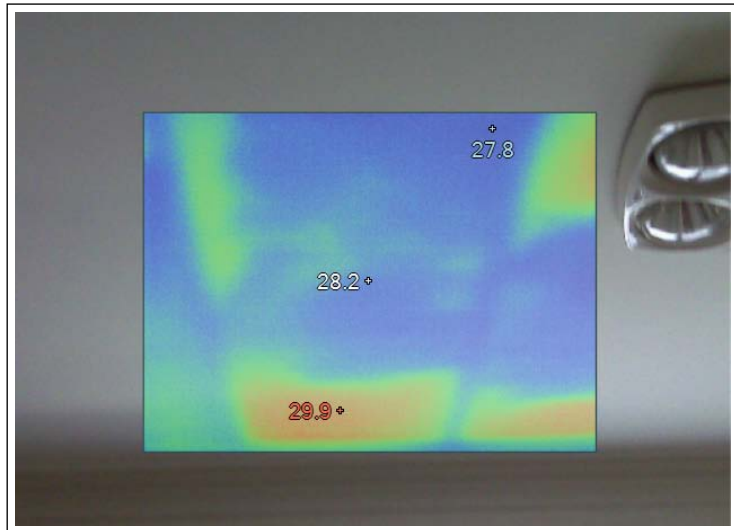
FIRST FLOOR BATHROOM

Obstructions:	Amenities and tiled walls
Visible Indications:	Nil
Location of Image:	Wall
Thermal Anomaly:	No thermal anomalies noted
Explanation:	No evidence of termite activity. The presence of termites is suspected when the temperature range in any image is greater than 5 degrees. As recorded in the image above, the temperature range is 2.1 degrees.
Recommendations:	Remove obstructions and re-scan. Risk of concealed activity/damage is high due to the obstructions. Risk of imminent attack is high. Re-inspect in six months.

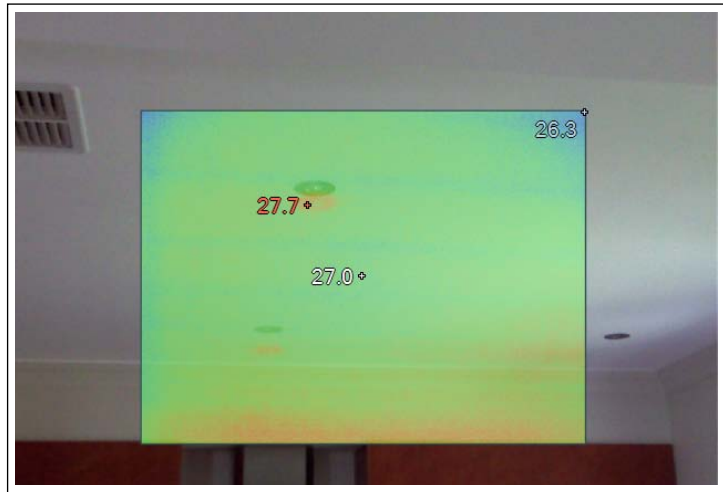
KITCHEN

Obstructions:	Cupboards
Visible Indications:	Nil
Location of Image:	Ceiling
Thermal Anomaly:	No thermal anomalies noted
Explanation:	No evidence of termite activity. The presence of termites is suspected when the temperature range in any image is greater than 5 degrees. As recorded in the image above, the temperature range is 1.4 degrees.
Recommendations:	Remove obstructions and re-scan. Risk of concealed activity/damage is high due to the obstructions. Risk of imminent attack is high. Re-inspect in six months.

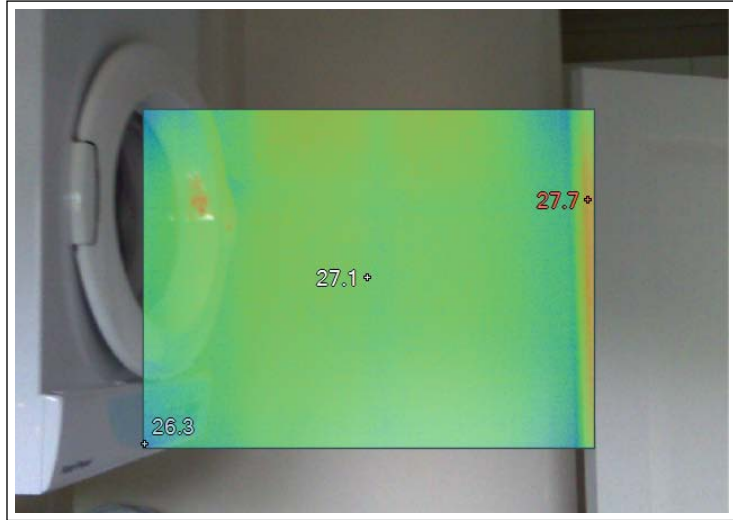
LAUNDRY

Obstructions:	Amenities
Visible Indications:	Nil
Location of Image:	Wall
Thermal Anomaly:	No thermal anomalies noted
Explanation:	No evidence of termite activity. The presence of termites is suspected when the temperature range in any image is greater than 5 degrees. As recorded in the image above, the temperature range is 1.4 degrees.
Recommendations:	Remove obstructions and re-scan. Risk of concealed activity/damage is high due to the obstructions. Risk of imminent attack is high. Re-inspect in six months.

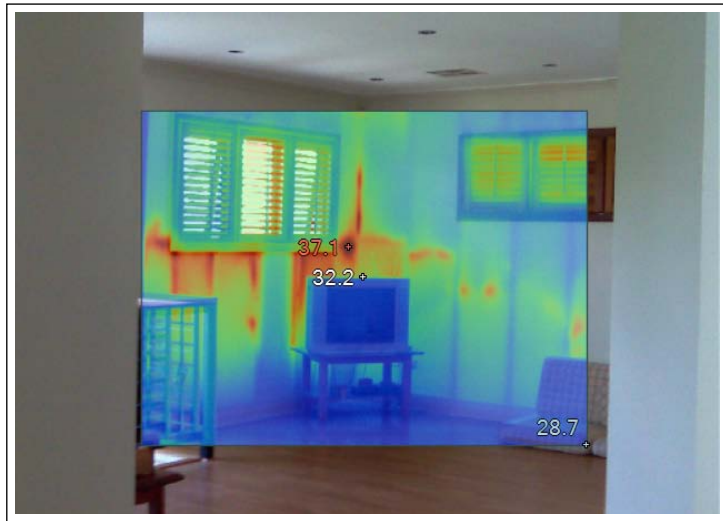
FAMILY ROOM

Obstructions:	Furniture
Visible Indications:	Nil
Location of Image:	Wall
Thermal Anomaly:	Thermal anomalies noted in left wall
Explanation:	Termite activity suspected. High thermal reading may be due to absorbed heat from direct sunlight. The presence of termites is suspected when the temperature range in any image is greater than 5 degrees. As recorded in the image above, the temperature range is 8.4 degrees.
Recommendations:	Undertake invasive inspection of the areas identified as thermal anomalies. (see Point 5 of Notes at end of Report). Remove obstructions and re-scan. Risk of concealed activity/damage is high due to the thermal anomaly and the obstructions. Risk of imminent attack is high. Re-inspect in six months.

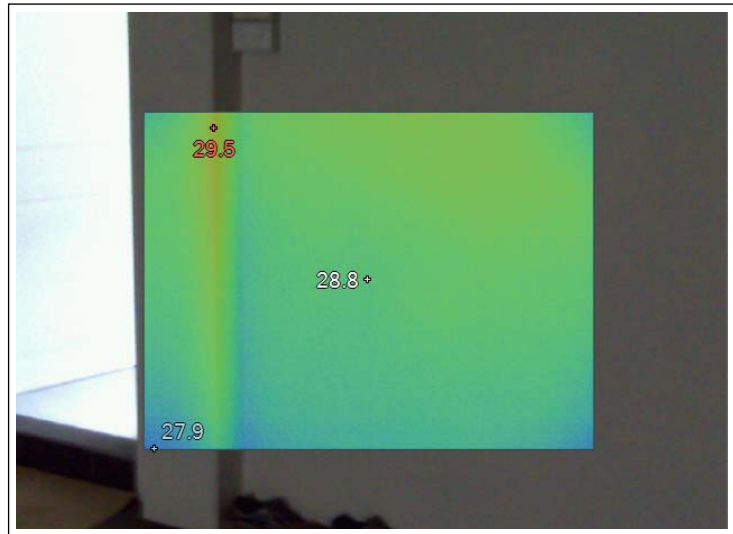
GARAGE

Obstructions:	Cupboards and personal effects
Visible Indications:	Nil
Location of Image:	Wall
Thermal Anomaly:	No thermal anomalies noted
Explanation:	No evidence of termite activity. The presence of termites is suspected when the temperature range in any image is greater than 5 degrees. As recorded in the image above, the temperature range is 1.6 degrees.
Recommendations:	Remove obstructions and re-scan. Risk of concealed activity/damage is high due to the obstructions. Risk of imminent attack is high. Re-inspect in six months.
